Condition Assessment Report for

The Grand Halle

The Former
Immaculate Conception
Roman Catholic Church Building

Landmarks SGA, LLC
and Terry A. Necciai, RA, Historic Preservation Consulting
January 2015

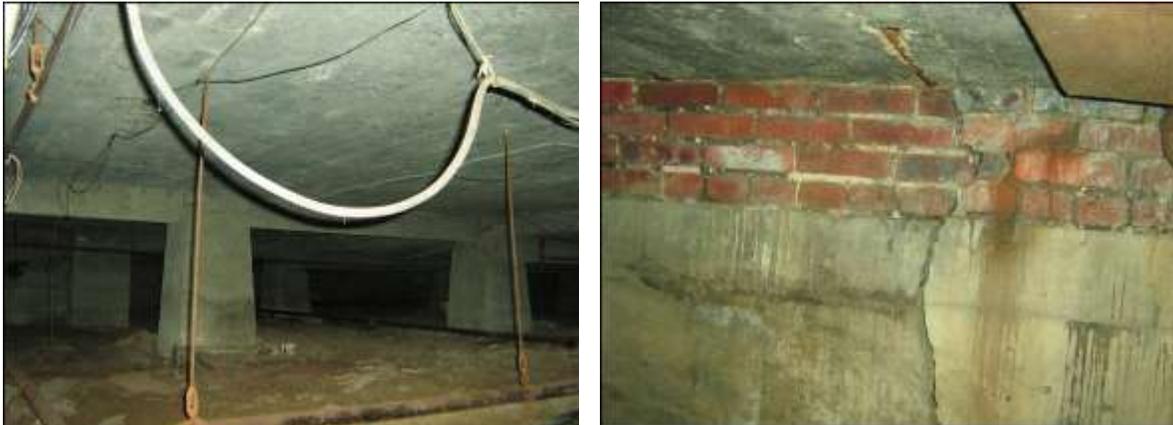
Truncated piers of poured-in-place concrete, as seen in the crawlspace (image on the left) support the floor slab (ceiling surface in both images). A closer-up view of the wall (image on right) shows that the builders used brick above grade on the inner side of the wall. The slab was installed above this. The concrete is a slightly different color, and the lines from pours and forms differ, all suggesting that the slab could have been added after the building was built. Note that the reinforcement rods in the slab are close to the bottom surface, rusting, and becoming exposed.

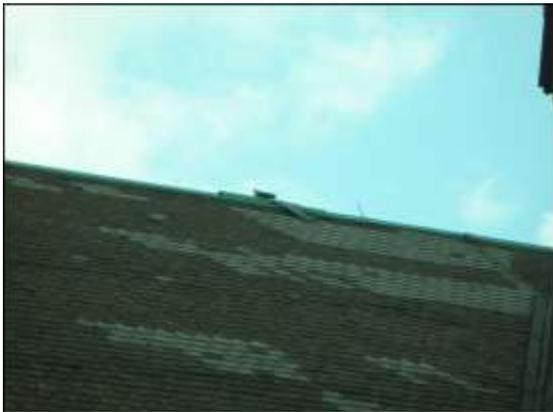
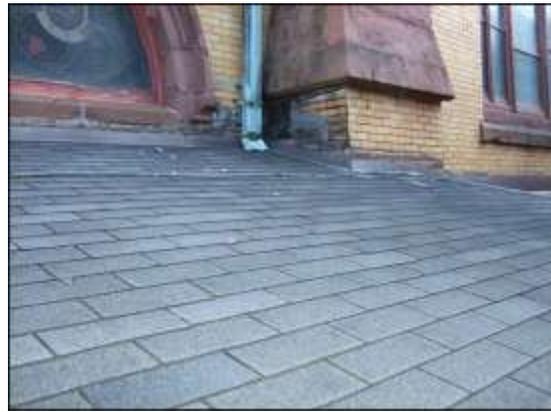
The image on the left shows the slate roofing with a color difference where slates have been replaced. The copper cresting at the top has begun to come loose. The image on the right shows the asphalt roofing on the lower roof and the broken rain leader discharging onto it.

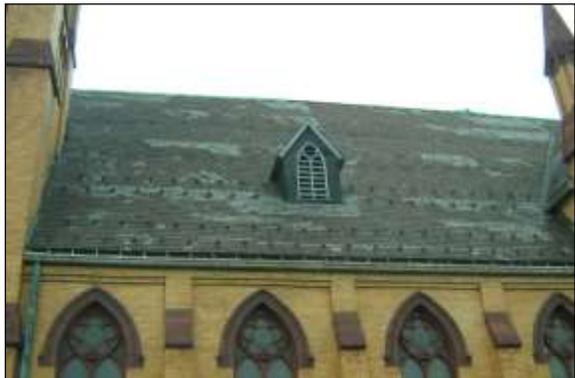
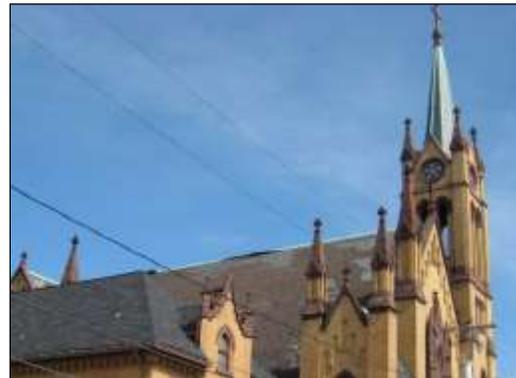
The silvery slates installed as replacements in 1959 are clearly visible in both images, as is the loose state of the roof cresting. The left image is from July 2014, and the right image is from April 2013. The left image also shows the snow guards, flashing at valleys and tower, and the gutters and rain leaders.

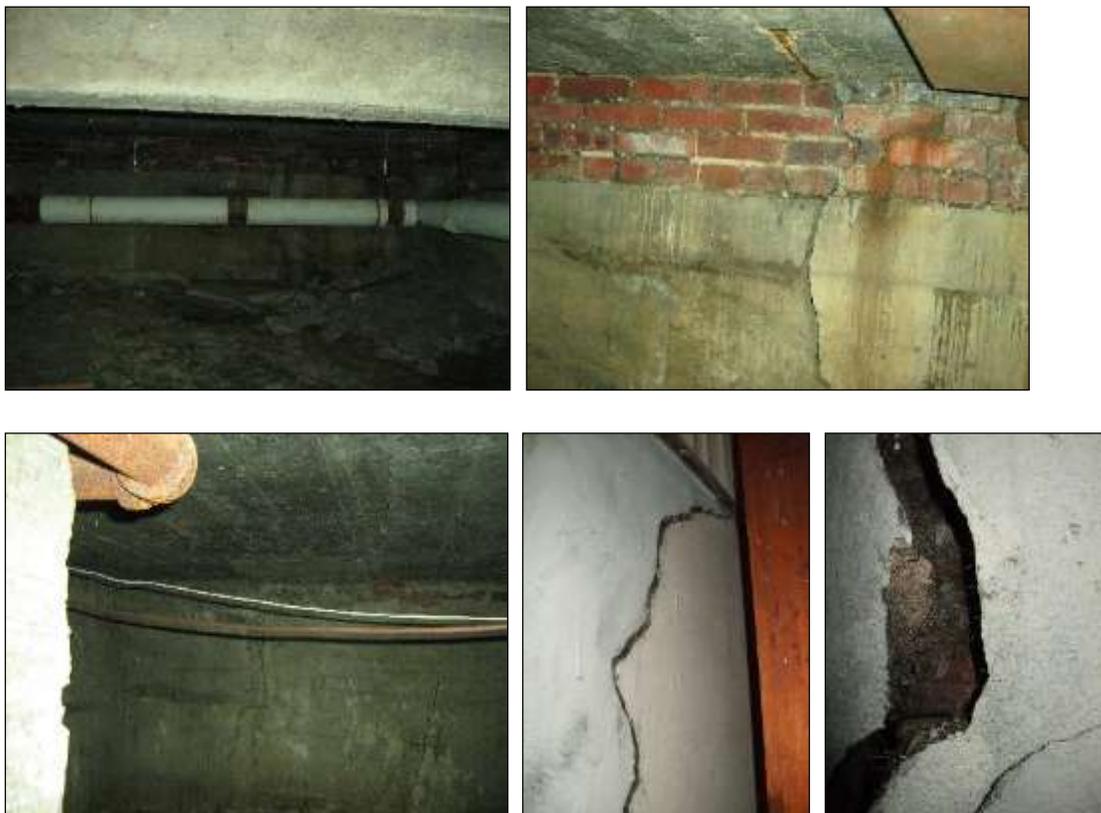
1. Foundation/Wall Crack: The foundation may or may not be reinforced concrete, and it may or may not have spread footings. The walls have cracked from the concrete foundation wall up through the bricks above the front door closest to the tower and also at the first window bay of the sanctuary. Essentially, the tower appears to be no longer connected to the rest of the building, although the floors are still aligned, the walls are still generally plumb, and the crack is old and not too wide (about 3/16 of an inch wide). The tower could still be connected by reinforcement in the foundation wall, or at the attic trusses, or other similar elements tying the building together. The crack is difficult to see in the crawlspace, because one has to crawl over 140 feet from the full height section of the basement to the corner at the base of the tower.

Crack in wall viewed from crawlspace. Crack in wall viewed from area behind organ.

Action: The existing crack should be monitored to determine if there is only seasonal movement and to watch for other movement that may represent a more serious condition.

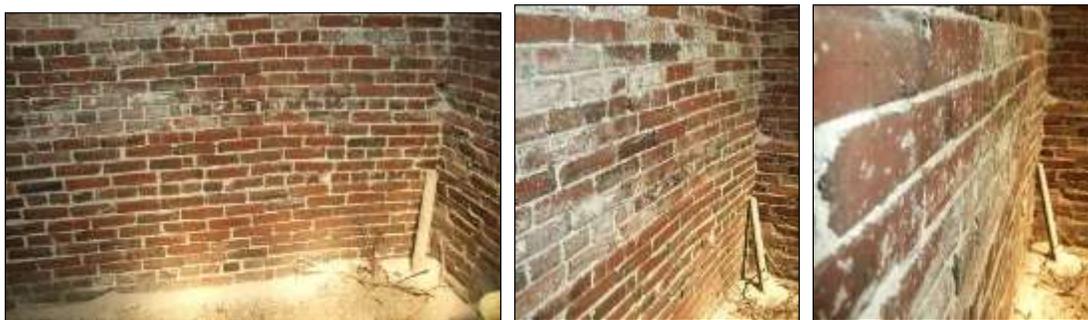
2. Bell Tower Wall Bulge: Possibly related to the above condition, there is a slight bulge and out of level condition in the brick coursing, in the northwest wall of the tower's second stage (the room at the top of the first ladder but below the belfry) where it meets the main attic area. The bulge may relate to a repair (made in the last 30 years) on the opposite side of the same truss (first truss in attic) where concrete was poured in an area above the lower tower to reinforce the bearing wall for this truss. The area of the bulge in the tower is the opposite bearing point for the truss, and the other side of the wall is visible only from the catwalk in the attic. The area of brick around the steel truss is not neatly formed and could be causing the bulge by being laid improperly for carrying the required load. This area is not accessible except by climbing across the plaster ceiling; therefore further investigation was not performed. (Photos are attached). There may be some evidence from the photos of darkened areas of the underside of the roof at this point which may be an indication of current or past roof leaks at the flashing to the tower wall. Movement in this area could be causing both a structural problem and a moisture problem, and either one can greatly accelerate the other.

Interior of the tower first level below belfry.

Action: The wall below the belfry should be monitored for further movement and other problems, such as moisture or disintegration of bricks due to movement and a crack opening up. It may be prudent in the future to engage the services of a structural engineer to evaluate this condition and follow any recommendations identified as necessary. The engineer or other personnel should check the site on a regular basis, possibly twice a year (based on a time of year when the temperature and humidity are high, and when the opposite weather conditions are present). The property should also be checked after periods of heavy or prolonged rain to look for evidence of moisture along the wall or the underside of the sheathing as well as any signs of movement at the cracks in the walls.

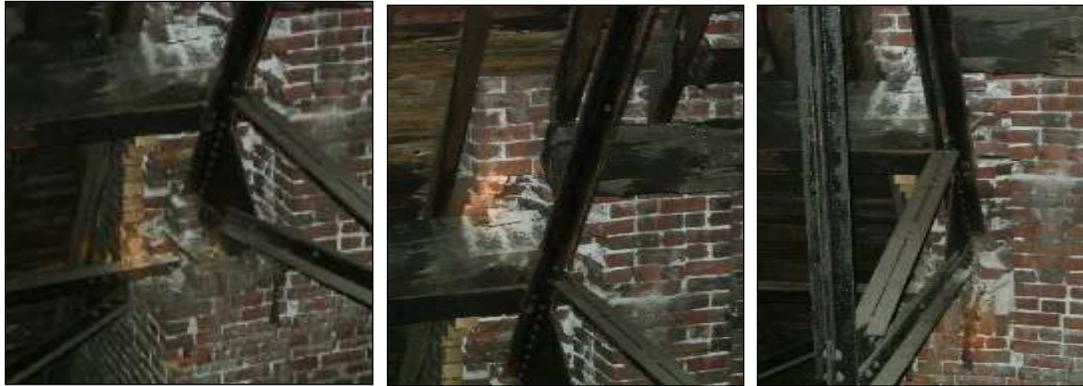
Exterior wall of the tower from the attic, showing roof truss bearing condition.

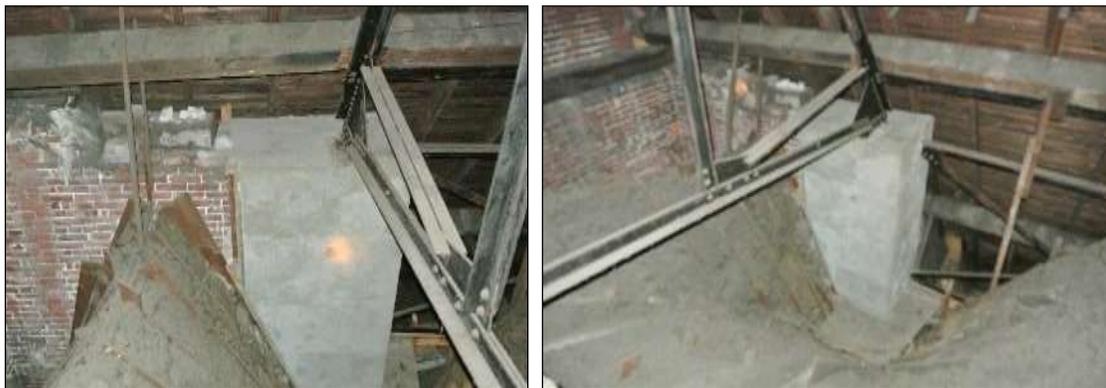
Opposite end of same roof truss showing previous repair to bearing wall.

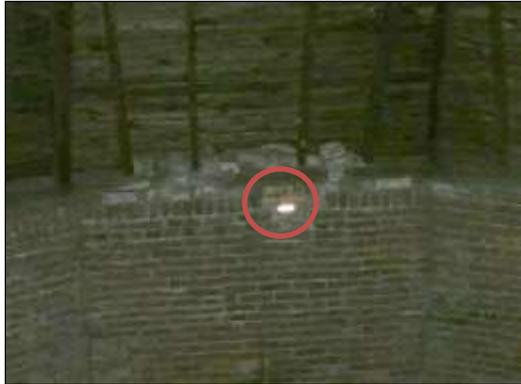
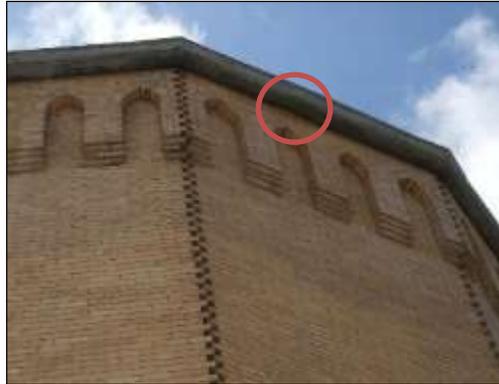
3. Missing or Dislodged Brick at Rear of Apse: The first photo taken from the attic shows the missing brick. It is not clear if there is a reason for this or if the brick has just become dislodged.

Photos showing location of missing or dislodged brick at rear of apse.

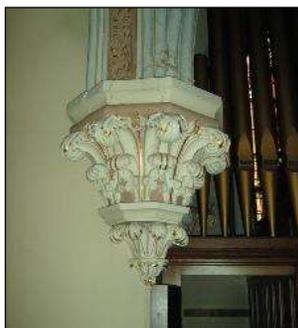
4. Plaster Ornament at Choir Loft: The plaster ornament at the corner of the choir loft is deteriorating and has pieces missing. The plaster was already broken when the current condition assessment project started in mid-summer 2014, but most of what is now missing (September 2014) broke free and fell out toward the end of the summer. The broken plaster may be the result of movement in the tower, as discussed above, or from the possible related water infiltration issues noted.

Plaster ornament in March 2013.

Action: The plaster ornament should be monitored closely for further damage and it should also be tested with a moisture meter to see if there is currently higher than normal levels of moisture present. Proper replacement of this ornament will require casting gypsum plaster to match intact details as they can be found.

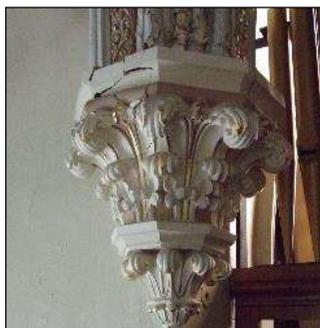
Plaster ornament on 7/30/14.

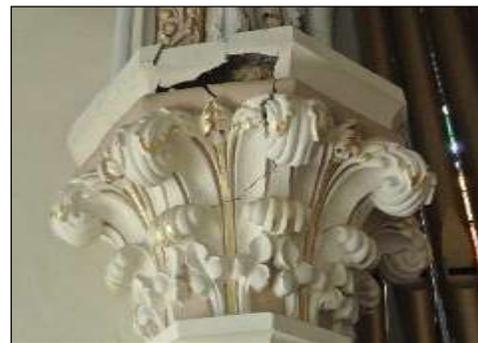
Plaster ornament on 9/18/14.

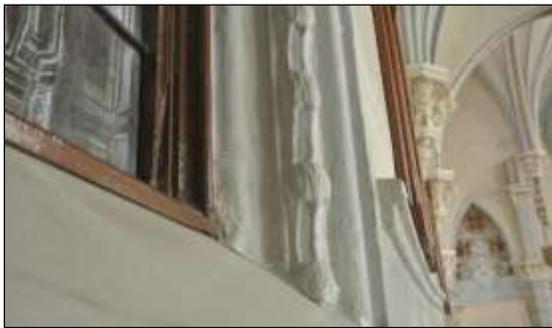
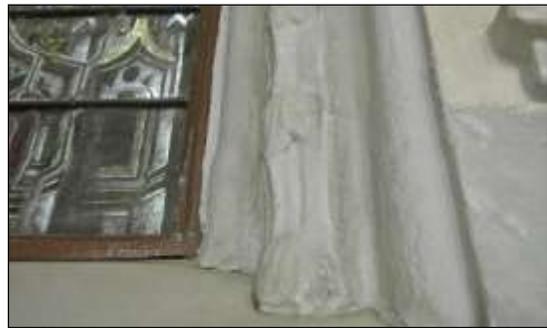
5. Ornamental Plaster Leaf Pattern around Windows: The leaf ornaments in the interior window surrounds are expected to be especially complex castings when it comes time to repair them. The design is challenging, not only because the rounded surfaces are complicated in the straight runs, but also because they curve at the top. Also, in plan, they are more than half a circle in radius while, at the same time, they are engaged in the wall (this is likely to require an unusual type of mold for recasting). In almost all areas with this detail, the leaf pattern appears to have lost much of its detail due to the way thick layers of paint have been applied over the years, and possibly also due to chronic moisture issues. At one or two window openings, a larger percentage of the details have been lost more recently at the top of the window opening due to some combination of wall movement and cracks opening in the wall from the top of the window through to the exterior brick, eaves, and gutter areas. The moisture caused efflorescence, dissolving some of the plaster as it moved into the cracks from above and then migrated through the plaster itself.

View of plaster leaf moldings at windows.

Action: The moisture sources need to be analyzed carefully and completely solved. The exterior openings need to be sealed. Any work needed to assure that the roof edge, gutters,

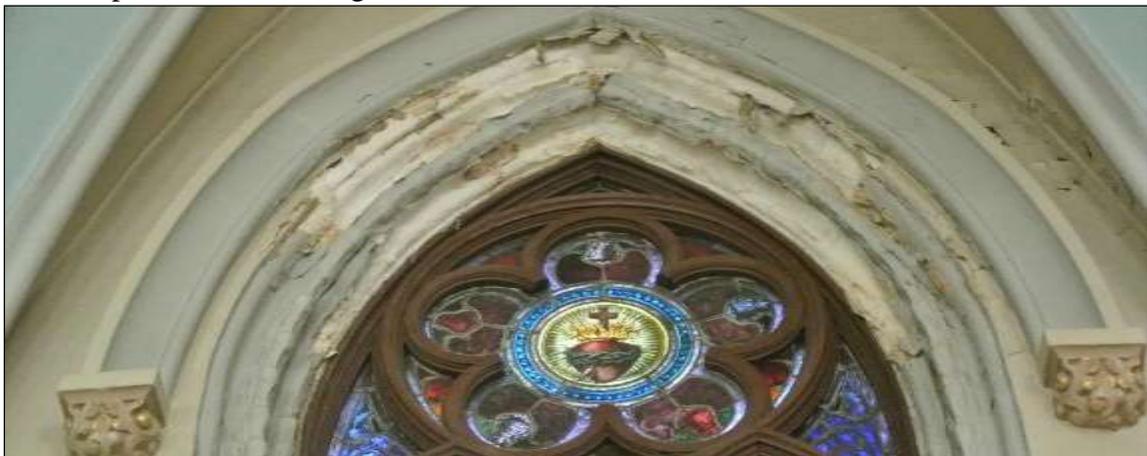
Photo of example of damage to decorative molding.

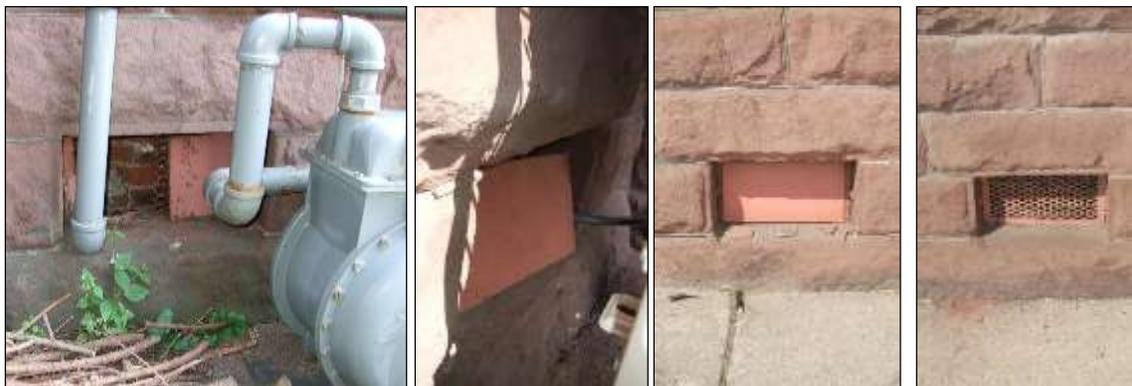
6. Crawl Space/Basement Ventilation: A number of the ventilation grilles placed at the bottom of the exterior walls along the Third Avenue and the former Rectory sides just above sidewalk level have either been completely or partially closed up by their use as chases for pipes, etc. In at least one case, the grille is missing and the remaining opening has nothing to prevent birds or rodents from entering.

Crawl space vent partially obstructed.-Crawl space vent closed.-Vent open and properly protected by grille.

Action: Moisture migrating upward from under the concrete slab and crawlspace areas combined with any that has entered through the foundation walls can be reduced by proper cross ventilation. Re-establish the designed ventilation for the crawl space/ basement at the six places where ventilators were originally installed. This involves placing rodent-proof grates over the openings and addressing any seasonal issues (e.g., addressing how accumulated snow and ice outside the wall melts without causing excessive moisture and salt to enter the building). This may mean installing operable vents that can be closed off in the winter when humidity is much lower and opened in the warm months when moisture is present. Since piping for the current cooling system reduces the size of the ventilation openings, it might be appropriate to consider a design that involves forced ventilation such as a fan to keep the crawlspace area dry.

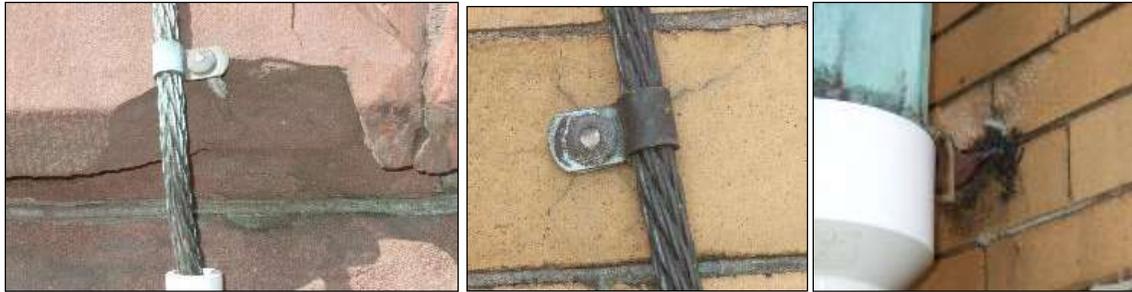
7. Brownstone/Brick Masonry Damage at Fasteners: Metal fasteners inappropriately placed directly into the brick or brownstone have caused damage and spalling of the masonry.

Brownstone and brick masonry damage caused by inappropriate fasteners.

Action: Remove inappropriate fasteners anchored into the bricks or brownstone (at rain leaders, lightning rod cables, etc.) as soon as possible. Where absolutely needed, new fasteners should be placed in new holes drilled into mortar joints, with lead or plastic plugs to keep the fastener from placing pressure on the adjoining masonry. (The selection of locations should be directed by an architect.) The broken brownstone areas at current fastener locations should be repaired using a cementitious or similar filler material color-matched to the stone. There are similar spalls in the brick, but they are less problematic; the spalls larger than one square inch at bricks should not be filled with cementitious materials; new bricks may be needed instead. The work should be designed and directed by an architect, particularly in areas where the bricks have been damaged.

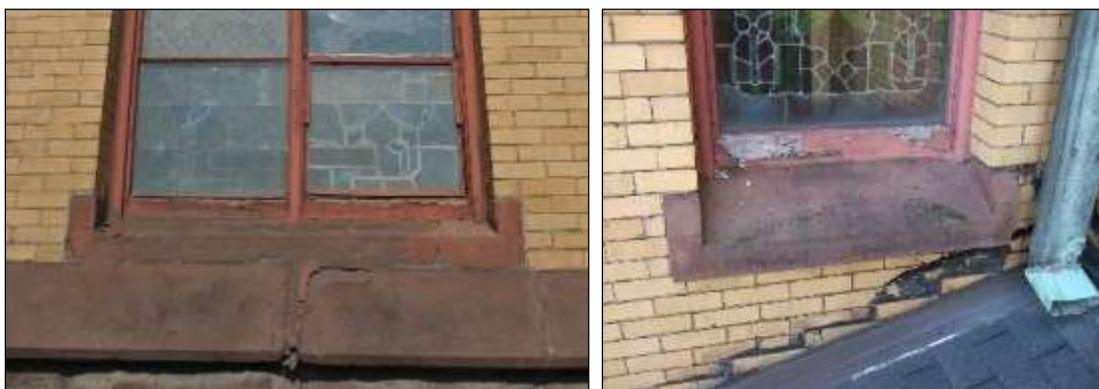
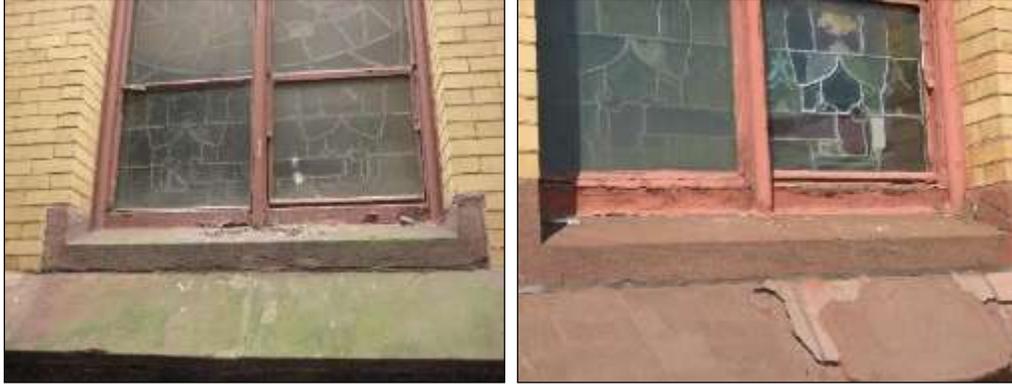
8. Repainting Exterior Trim: Almost all painted exterior wood or metal trim on the building needs to be properly prepared and painted. This includes the window trim, the basement window and door, all painted door jambs, the attic ventilators, any exposed eave areas (for instance, at the attic ventilation dormers), etc.

Photos of window trim and sill.

Action: Undertake a maintenance plan which includes a schedule for repainting these areas. Those items that are high on the building or roof will need to be contracted to a company that is properly equipped to handle the work.

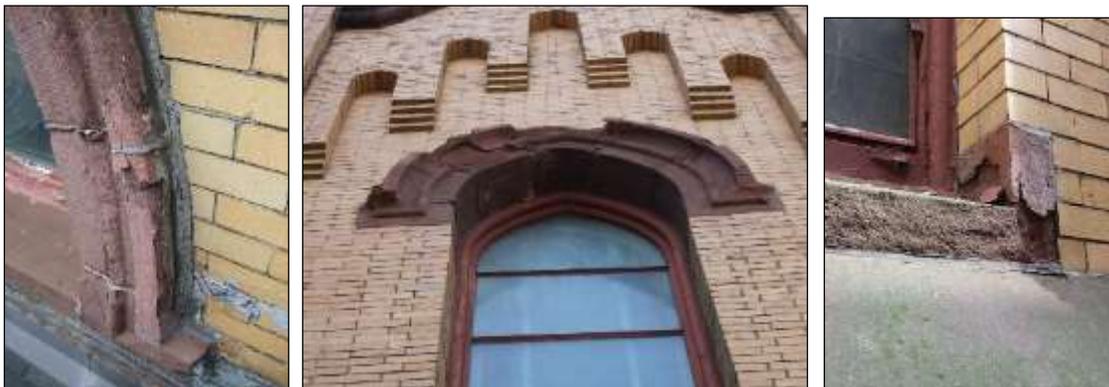
9. Exterior Brownstone Trim Pieces: There are areas where the brownstone trim, particularly at window openings, has deteriorated and pieces have delaminated and are missing.

Photos of damage to brownstone trim below and around windows.

Action: These areas need to be investigated to make sure they are watertight since it is possible that these are sources of moisture infiltration into the building. Missing areas of trim can be fabricated using cementitious materials and other broken pieces repaired with sealant. Loose pieces should be removed where they appear above shoulder height, especially in any area where there is a walkway directly below.

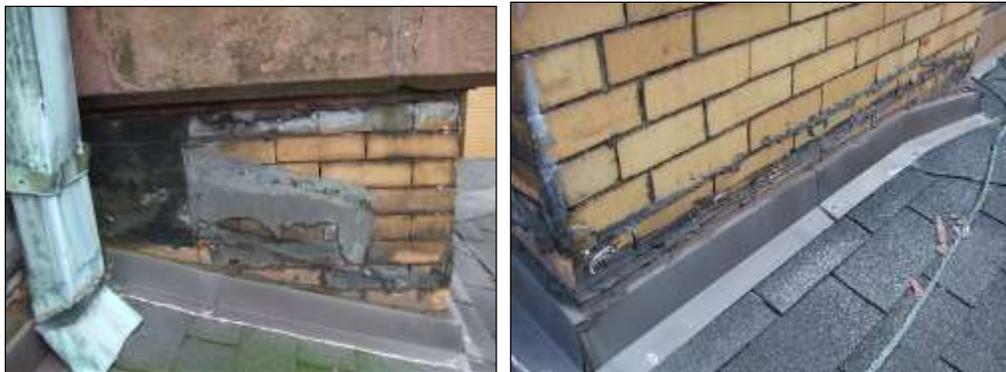
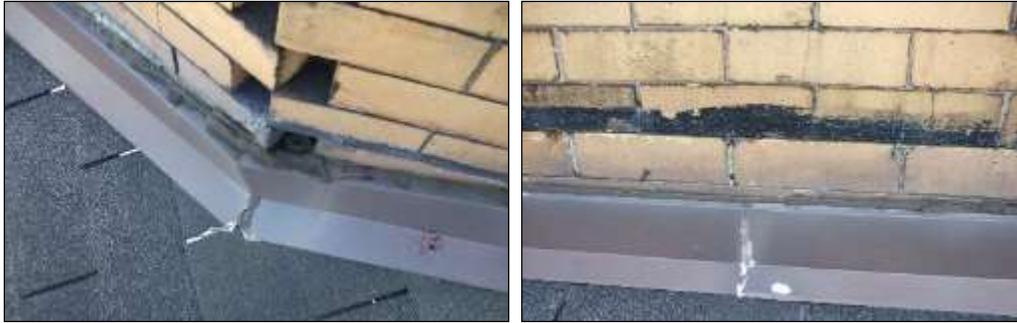
The single-story roof areas are estimated to be about a 4/12 pitch. Even though this is above the minimum slope requirements of shingle manufacturers, it is not steep enough to prevent the build-up of ice and snow, particularly against the higher wall of the main structure. Due to the orientation of the building, the snow and ice does not clear and poses a potential problem for ice dams when it builds up in the gutter and then backs up under the singles. Once it contacts the warmer air within, it melts and saturates the wall and portions of the adjacent roof. At the time of the shingle installation, the practice of installing an “ice and water shield membrane” may not have been available, so protection from this condition was limited. There is no ice melt or heat cable installed on the lower roof edge and gutter.

Photos of lower roof flashing to wall.

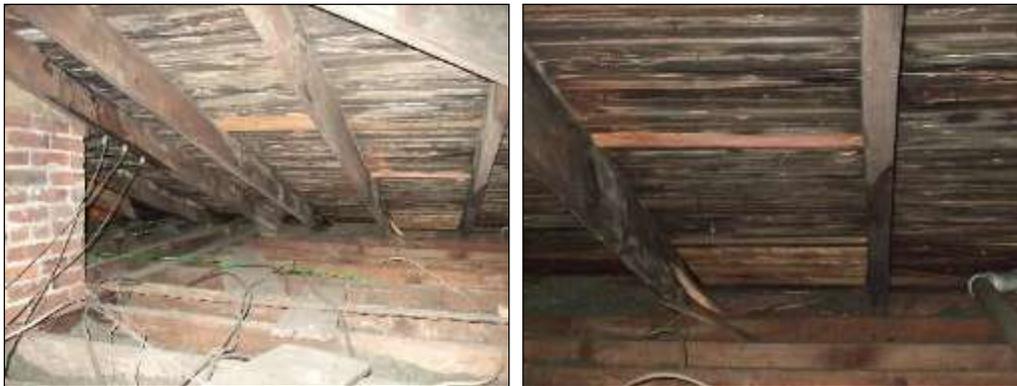
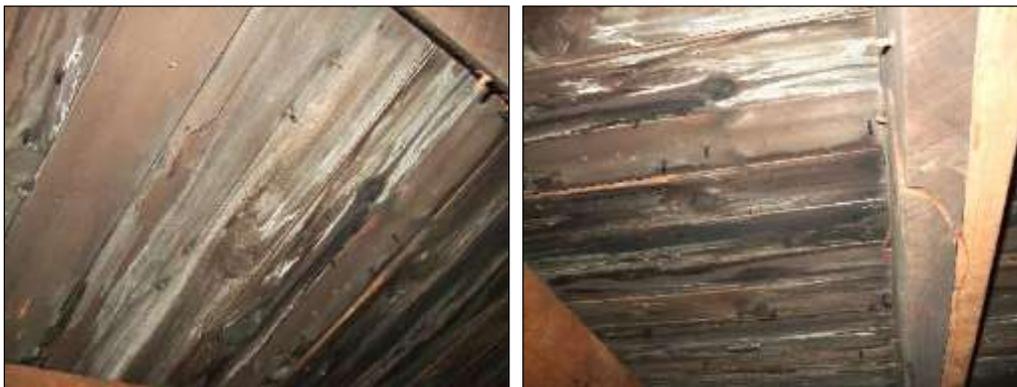
Photos of underside of roof sheathing from access panel above Sacristy.

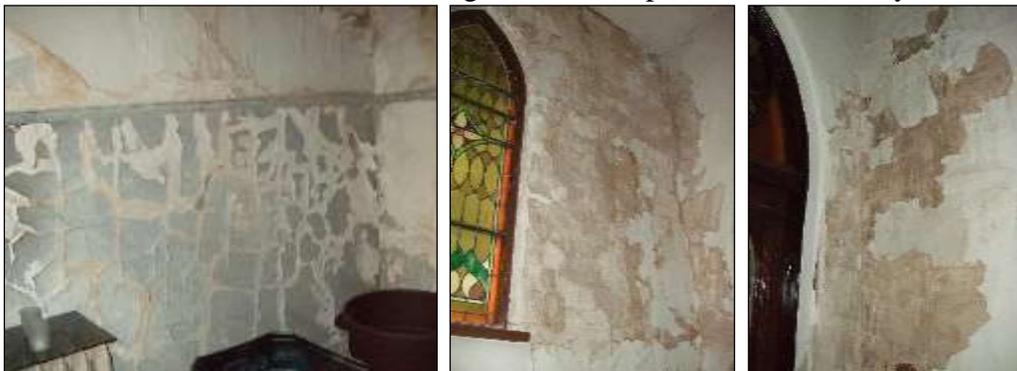
Photos of water damage to paint at exterior wall of restroom area.

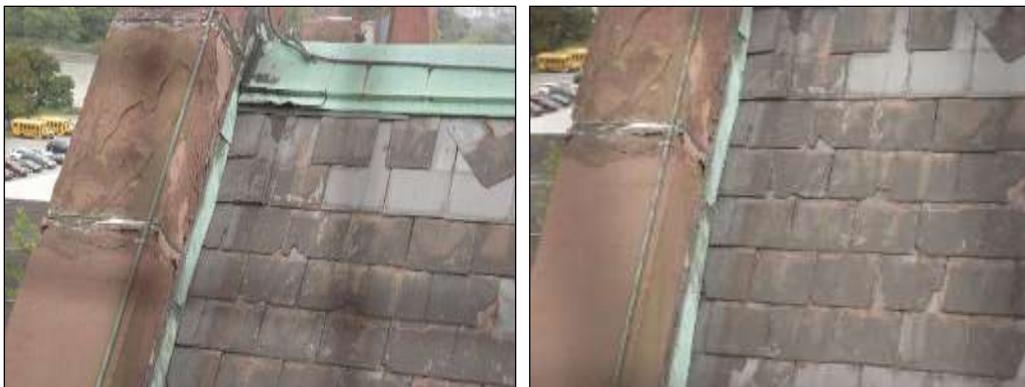
11. Parapet Walls at Roof: There is some deterioration of the parapet wall and coping (extending above the roof) at the front building wall. This was observed from the tower belfry and documented in photographs taken recently for this report. The rectory side was not visible and should be checked as well. Damage consists of spalling and deteriorating brownstone, mortar joints in poor condition, and flashing that needs to be repaired/replaced. There is also damage to the brownstone from fasteners used for the lightning protection system. Eliminating the possibility of water infiltration in these areas is important for protecting the interior of the building from future damage.

Photos of front parapet wall from tower belfry.

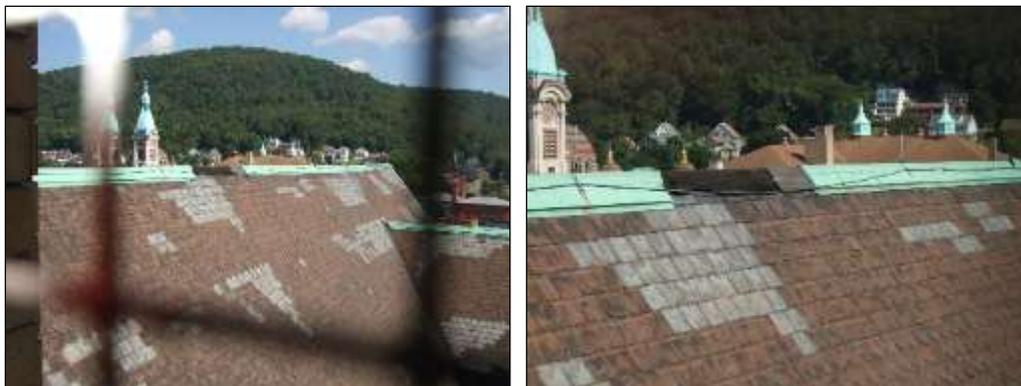
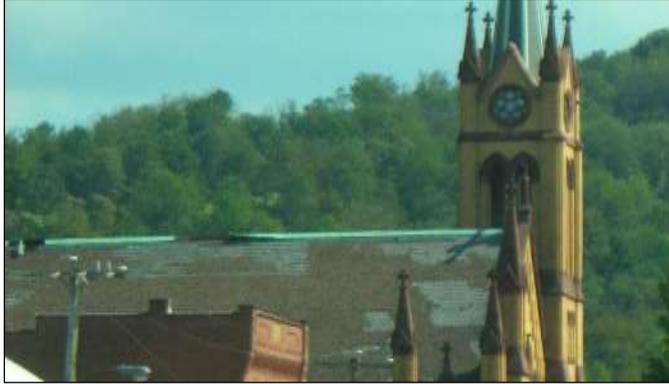
12. Sections of Copper Roof Ridge Cap Are Missing or Damaged: At least three of the copper ridge cap sections are missing, including one section on the Third Avenue side and at least two sections on the Rectory side. Limited observation (due to limitations to access) in the attic area revealed only a small amount of water infiltration below the missing section on the Third Avenue side, mostly confined to a small disturbed area in the insulation on the ceiling directly below the missing roof cap. It was not wet at the time of visit.

Photos of missing ridge cap section from tower belfry.

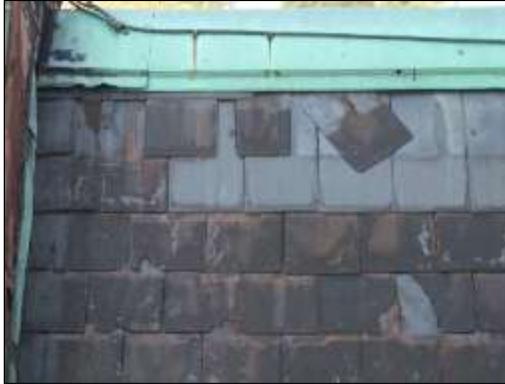
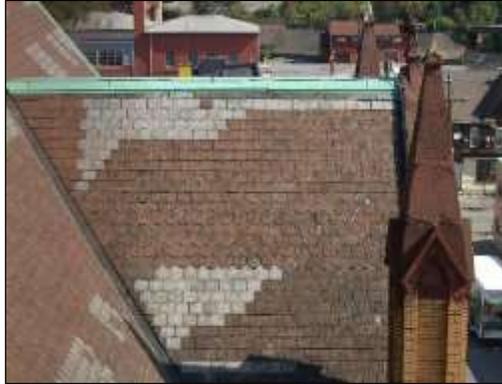
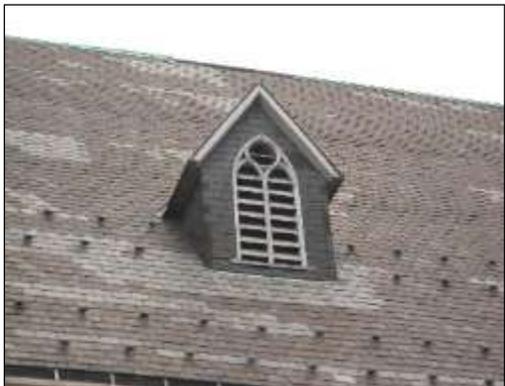
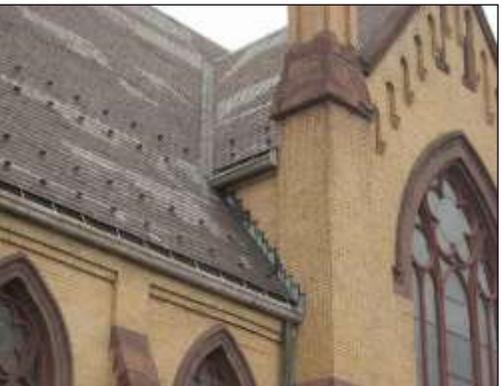
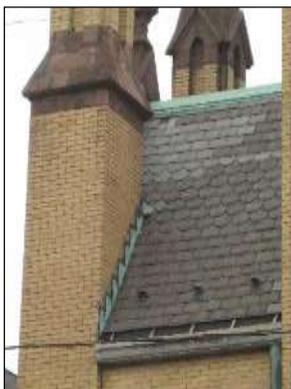
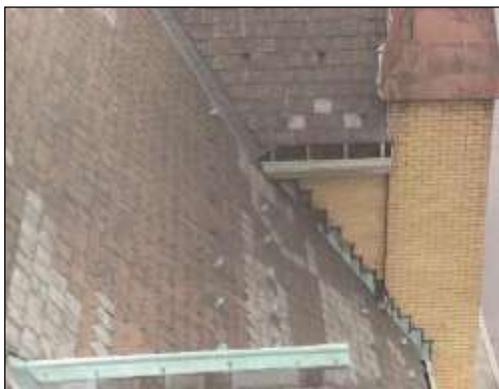
Photos of slate roof.

evidence of water staining on the underside of the wood and bricks under this part of the roof as indicated in a previous section of this report. This may have been repaired at some point in the past or may be a recurring problem.

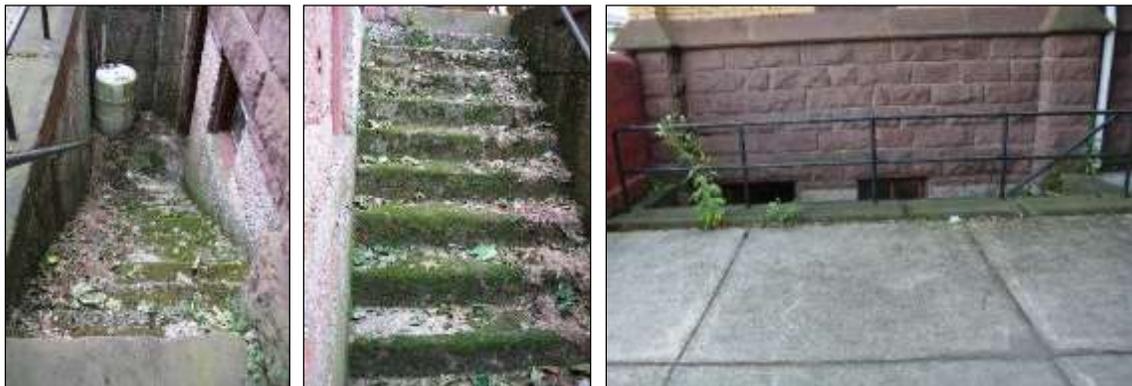
14. Exterior Basement Concrete Steps and Landing: There is a layer of moss and debris on the basement stairs and landing. This is creating a condition where water is standing on the concrete and it is not drying out. Eventually the concrete will deteriorate, especially from freeze/thaw conditions, and will require repair/replacement.

Photos of exterior basement stairway.

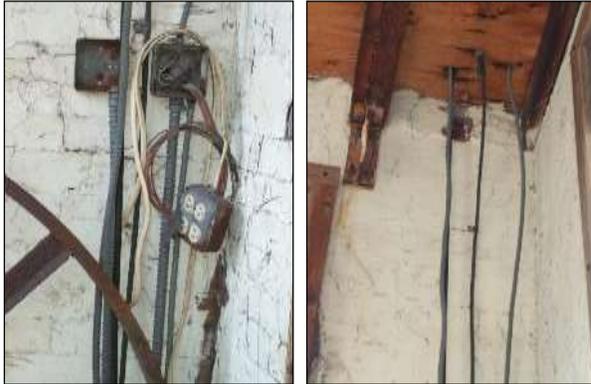
15. Electrical Wiring in Belfry: Electrical wiring and receptacles located in the belfry level do not meet code and are not sufficiently weatherproof for the environment in which they are located. It is not known what circuits are currently live and outlet boxes and cable are not permanently fastened to the wall. The junction boxes also do not have covers and are exposed to weather.

Photos of exposed wiring in belfry level.
